Lewiston Fire Department

Fire Station Analysis

Lewiston, Idaho

April 30, 2020

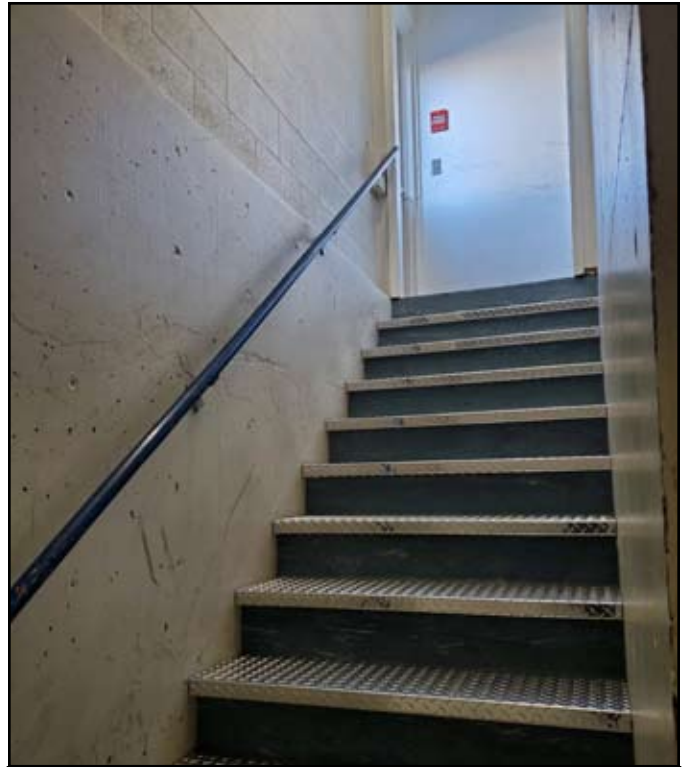
STATION 1: STAIRS TO BASEMENT

Diamond plate on stairs to make durable for training.
Using for training as other options not available.

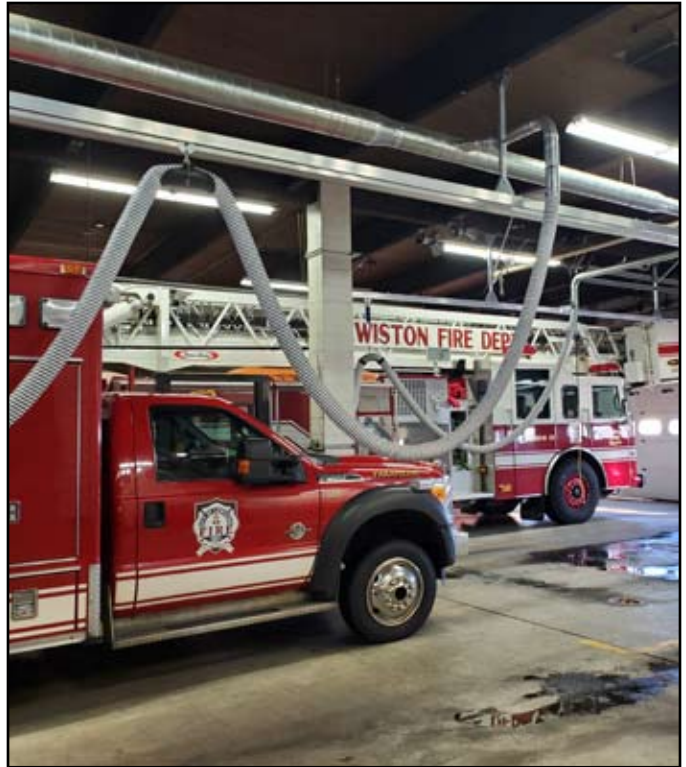
STATION 1: APPARATUS BAY

- Concrete apparatus bay slab- inadequate drainage for today's standards and non-structural cracking was observed throughout the station where slabs were exposed.

Floors do not drain properly.
Vehicle exhaust shown.

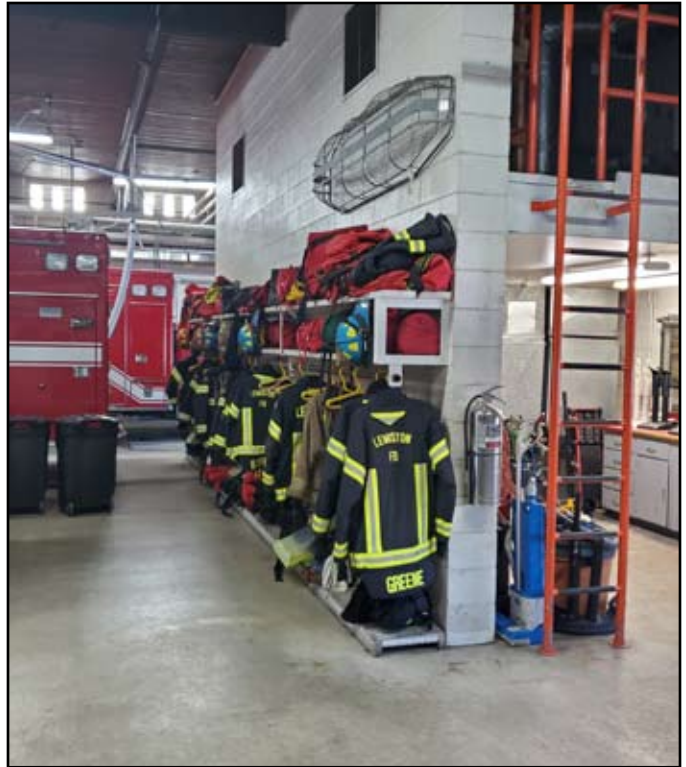
STATION 1: APPARATUS BAY

Turn outs stored in apparatus bay. Extra gear stored in apparatus bay due to lack of storage.

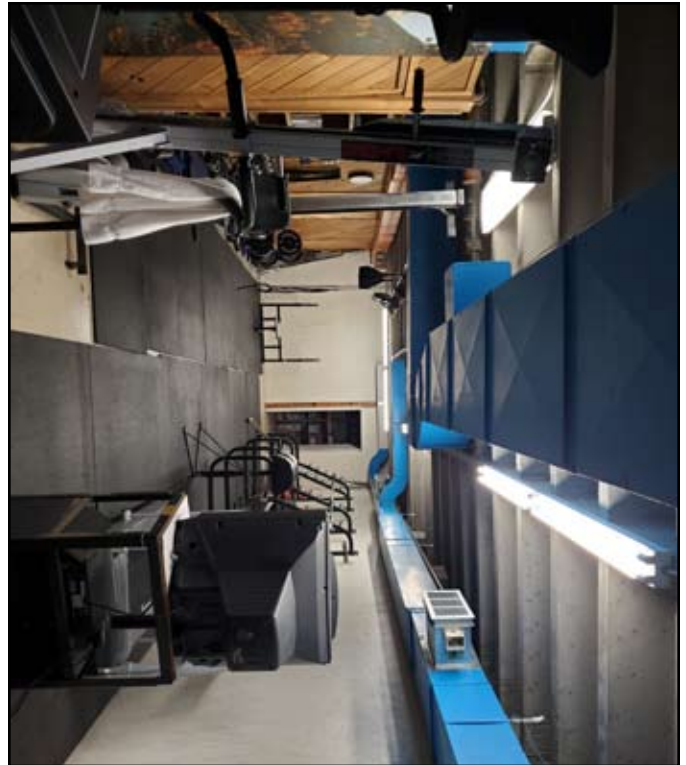
STATION 1: BASEMENT EXERCISE ROOM

Low ceiling and door ventilation for an exercise room.

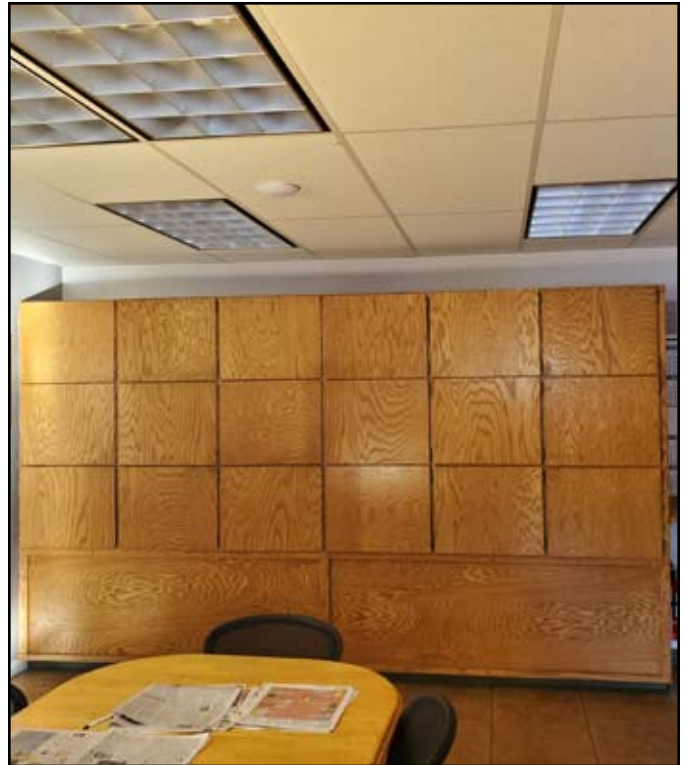
STATION 1: ENT. TO SLEEPING ROOMS
No fire rated separations to sleeping areas.

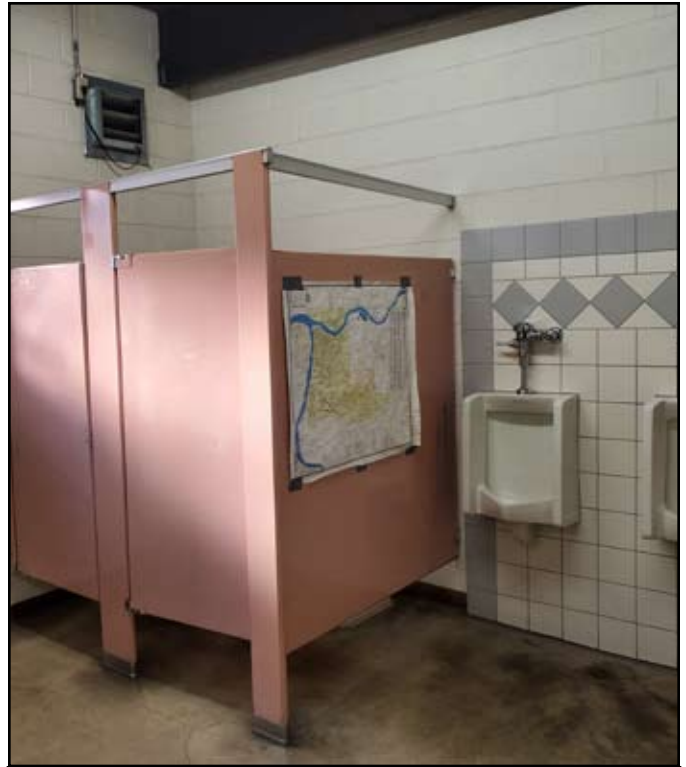
STATION 1: RESTROOM
Very dated. No ADA access.

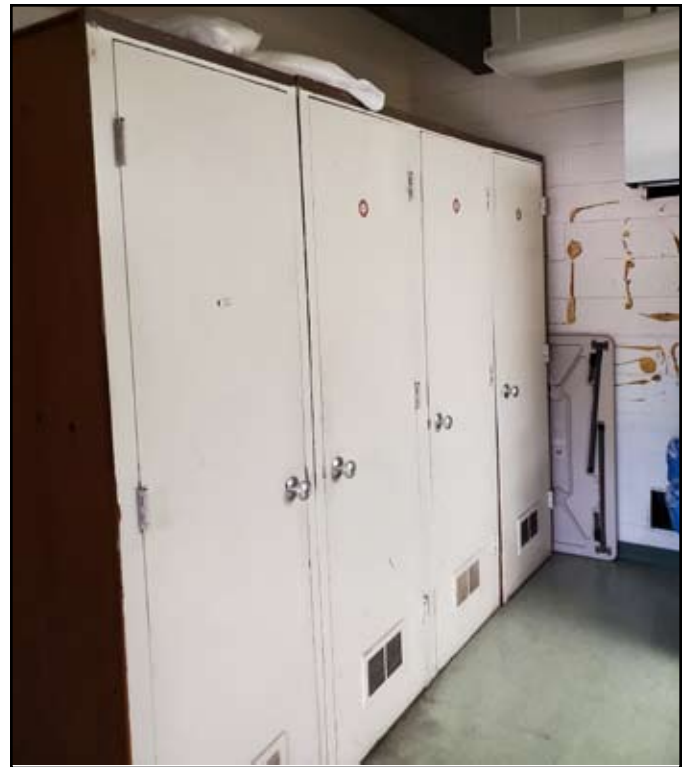
STATION 1: SLEEPING ROOM

Little privacy or seperation. Very small spaces.

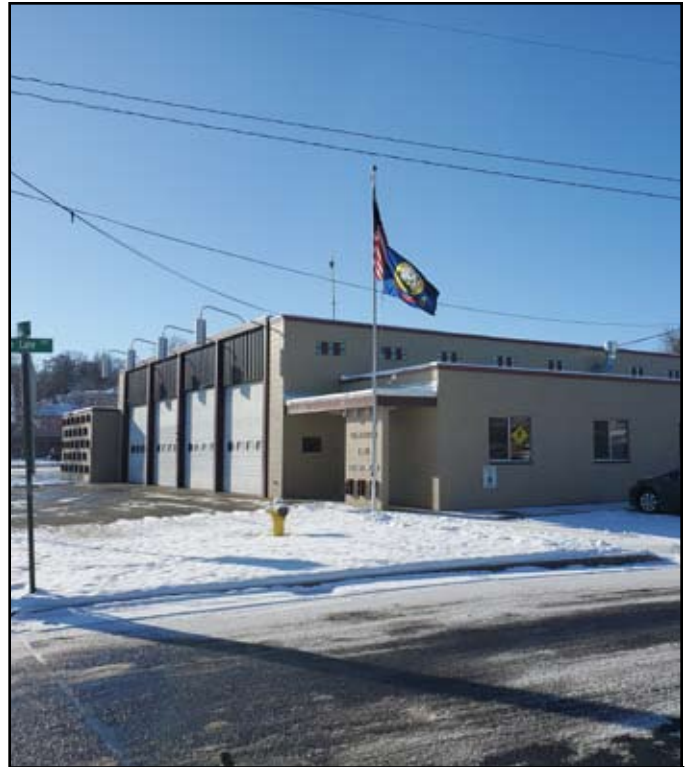
STATION 1: STAFF ENTRANCE
Dangerous slopes, doors don't meet ADA.

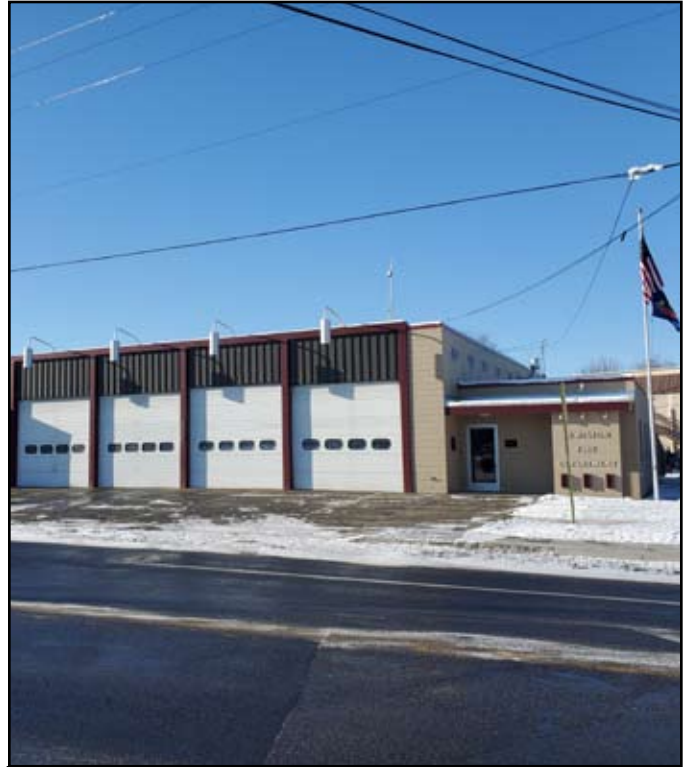
STATION 1: WEST SIDE DAY ROOM ADD.
Small storage building due to lack of storage in building.

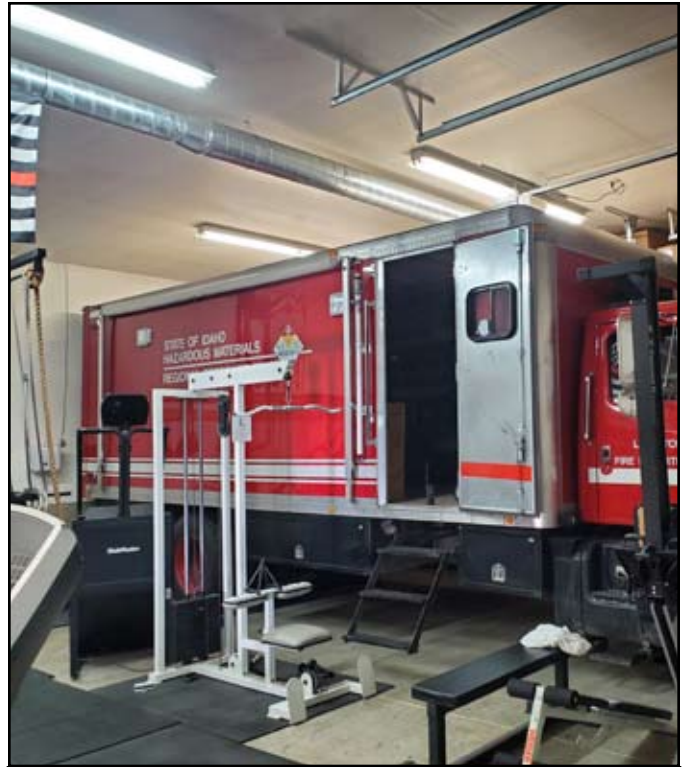
STATION 2: ANNEX APPARATUS BAY
Exercise area in apparatus bay.

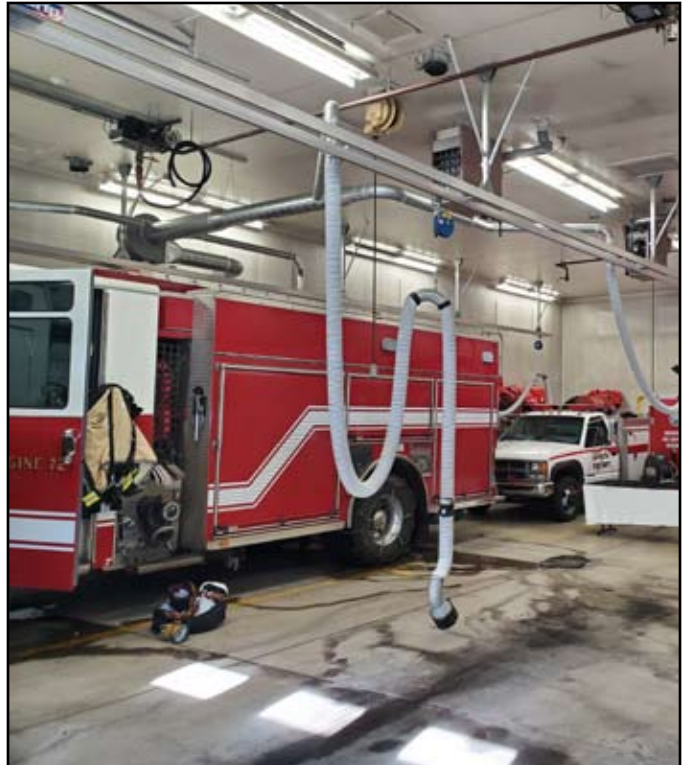
STATION 2: APPARATUS BAY
Poor floor drainage. Vehicle exhaust provided.
No general exhaust.

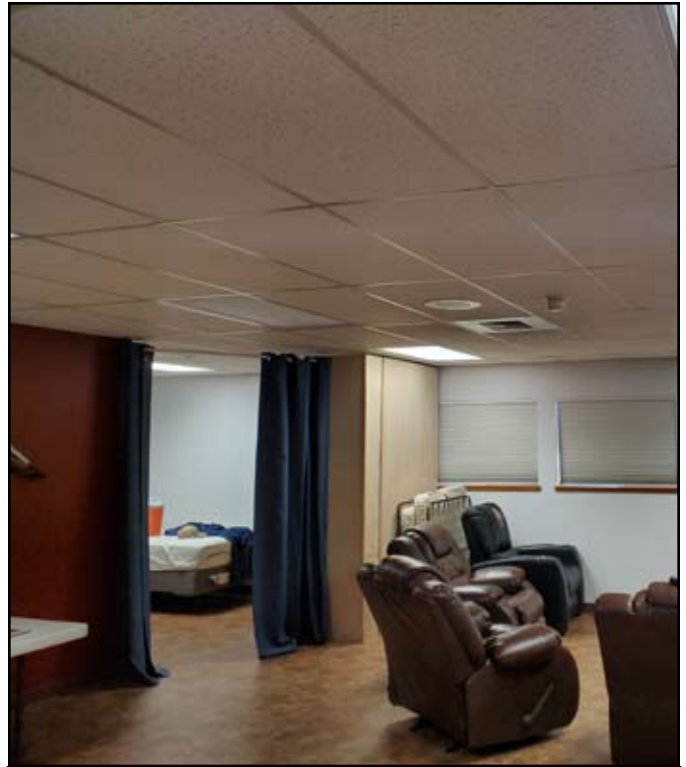
STATION 2: DAY ROOM / SLEEPING AREA
Sleeping area added in corner of dayroom due to lack of space.

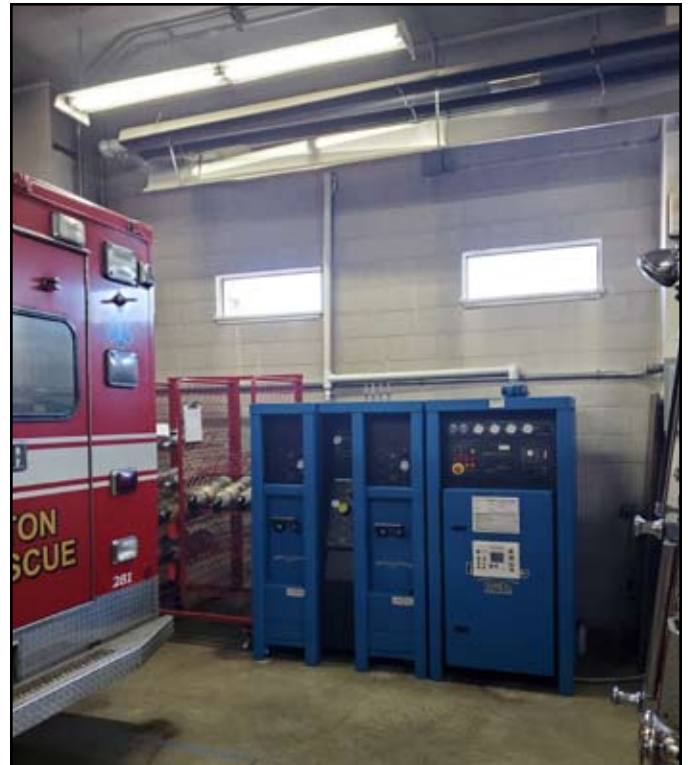
STATION 4: SCBA APPARATUS BAY

SCBA in apparatus bay, should be in a separate room.

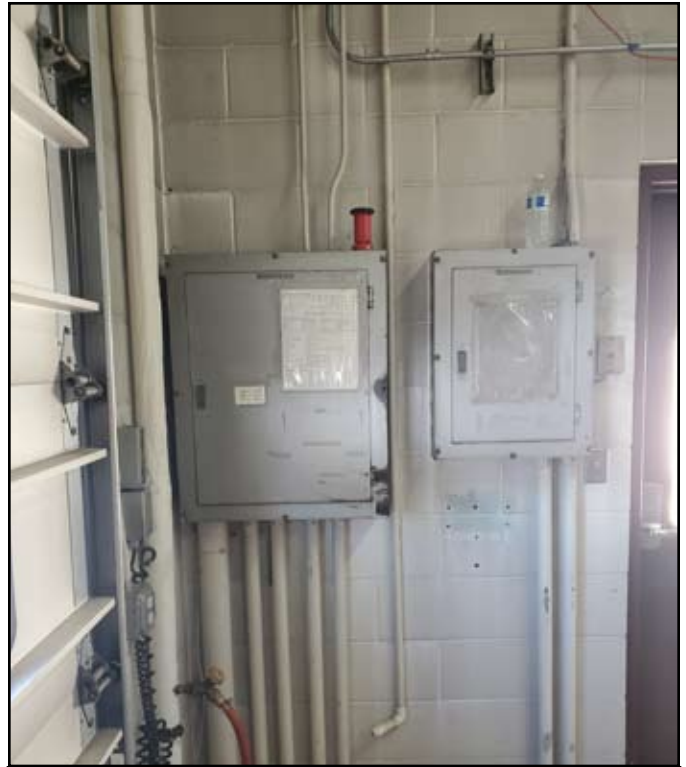
STATION 4: ELECTRICAL PANELS

Very old, located in apparatus bay.

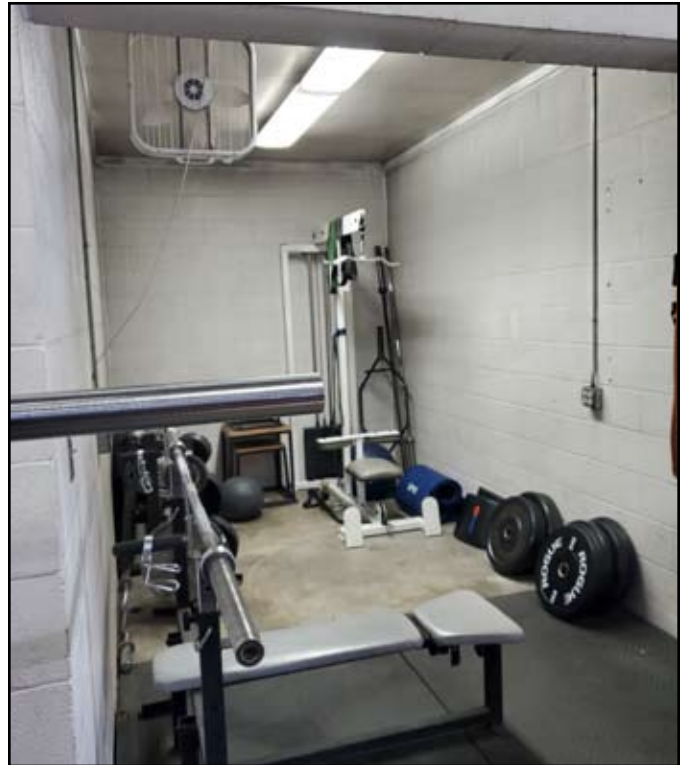
STATION 4: EXERCISE ROOM OFF APP. BAY
Alcove off apparatus bay.
Should be in separate room.

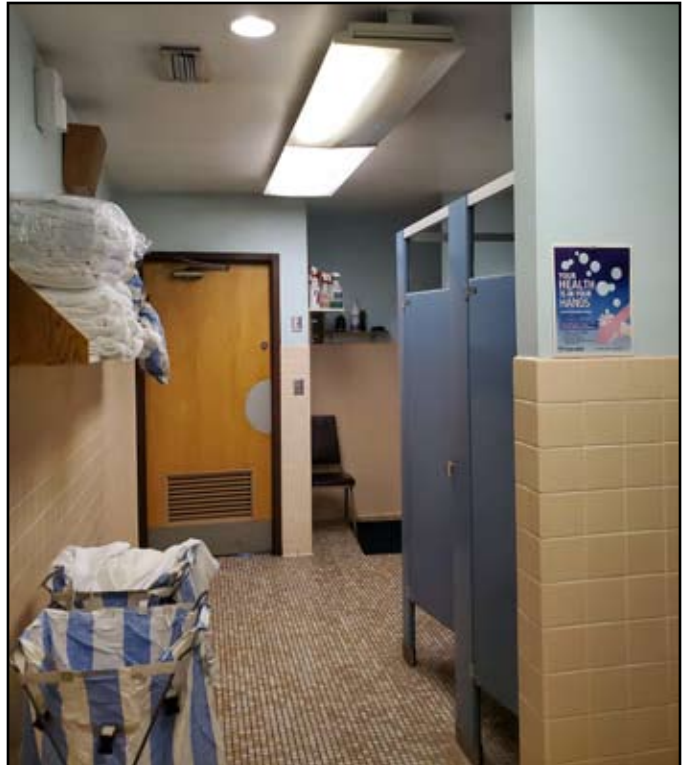
STATION 4: RESTROOM
Not ADA accessible. Only restroom in building.

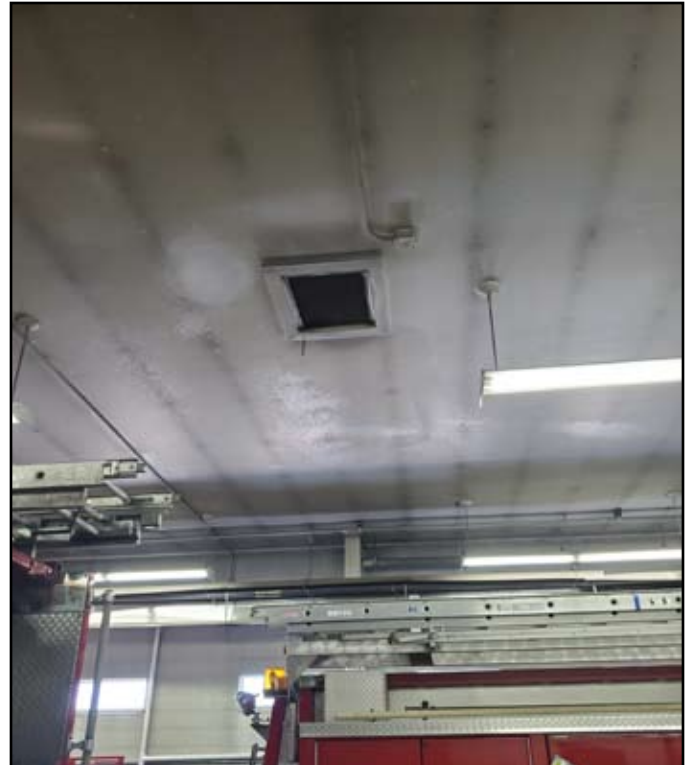
STATION 4: CEILING IN APPARATUS BAY
Diesel exhaust on ceiling due to lack of vehicle exhaust system.

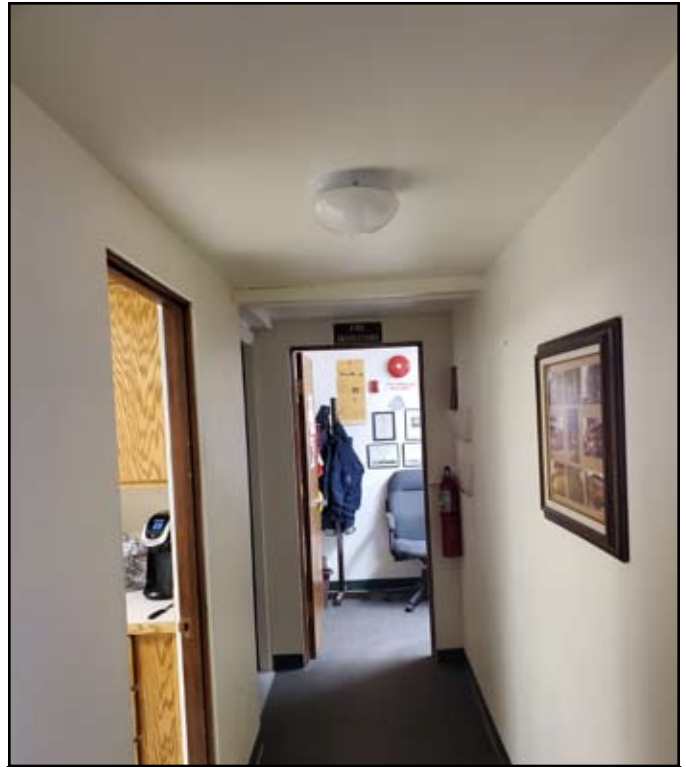
ADMIN: BASEMENT HALLWAY

Second egress goes thru an office shown beyond.
